TECHNICAL REPORT  
EP-108

DESERT FLOOD CONDITIONS IN THE WHITE MOUNTAINS  
OF CALIFORNIA AND NEVADA

QUARTERMASTER RESEARCH & ENGINEERING CENTER  
ENVIRONMENTAL PROTECTION RESEARCH DIVISION

APRIL 1959

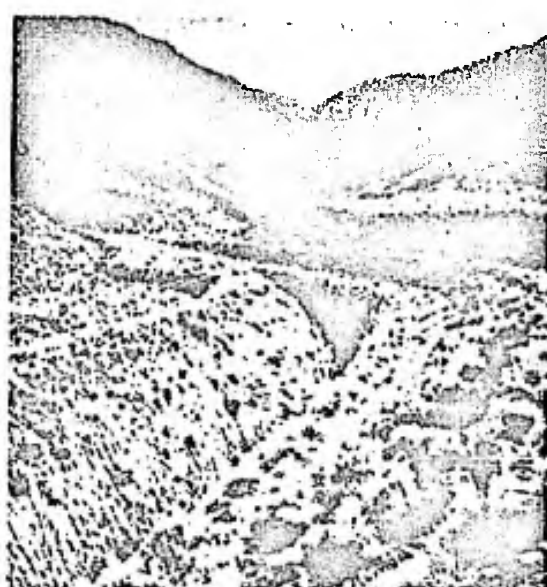
Figure 40. Lateral ridges along active channel in lower Straight Canyon deposited by flood of 1918. The channel is about 10 feet deep and 20 feet wide. Despite its artificial appearance, it is a natural feature. One lateral debris ridge appears in the right foreground near the right edge of the photograph and can be followed upstream beyond the prominent terrace in the middle distance. The lateral ridge in the left half of the picture is on the upper edge of the channel and appears especially clearly at the first upstream bend. The lateral ridges are about three to four feet high and four to eight feet wide at their bases.
